Ultrasonic inspection of damage report

超声波探伤报告

Report No. : 报告编号: 2017-1		Print time: 报告打印时间: 2017-04-23 00:00:26	
Damage No. : 缺陷编号: 1		Damage storage time: 缺陷存储时间: 2017-04-23 00:00:47	
Machine model : 仪器型号: TS2008D-B01A-A	Detector type 探头类型: 单直	Sonic velocity of material : 材料声速: 5921.90	
Machine No. : 仪器编号: 1	Nominal frequency: 标称频率: 2.5	Surface compensation: 表面补偿: 0.0	
Casting name: 791 plate hammer 工件名称: 791板锤	Nominal K value: 标称K值: 0.00	Judge deviation: 判废偏移: -4.0	
Casting No. : 工件编号: HAZ791-1	Crystal size: 晶体尺寸: 14.00	Quantitative deviation: 定量偏移: -10.0	
criterion of detection : 检测标准: JB4730-9	Forward position of detector: 探头前沿: 0.0	Length deviation 测长偏移: -16.0	
Damage curve and parameter: 缺陷波形及参数:		Damage depth 缺陷深度(Y): 92.63

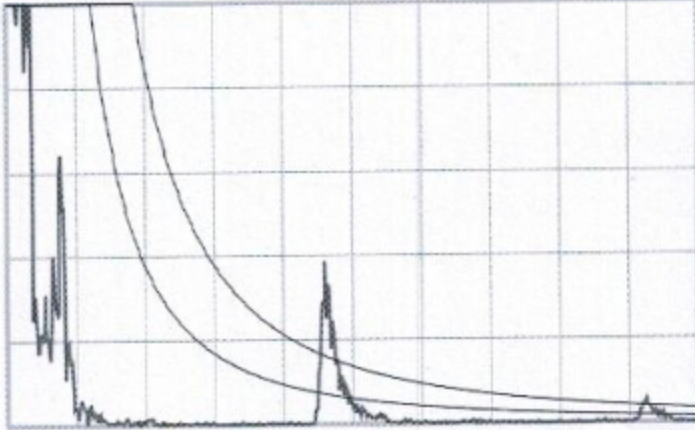
Damage Level 缺陷水平(X): 0.00	
		Damage amplitude 缺陷波幅(%): 38.8%	
		Damage equivalent 缺陷当量: 4.66	
		Current gain 当前增益: 34.9	
		Current sound path 当前声程: 200.00	
		Suggestion 处理意见:	
Class of damage: 缺陷等级:		Result : qualified 评定结果: 合格
